Bone Scan – Healing Stress fracture

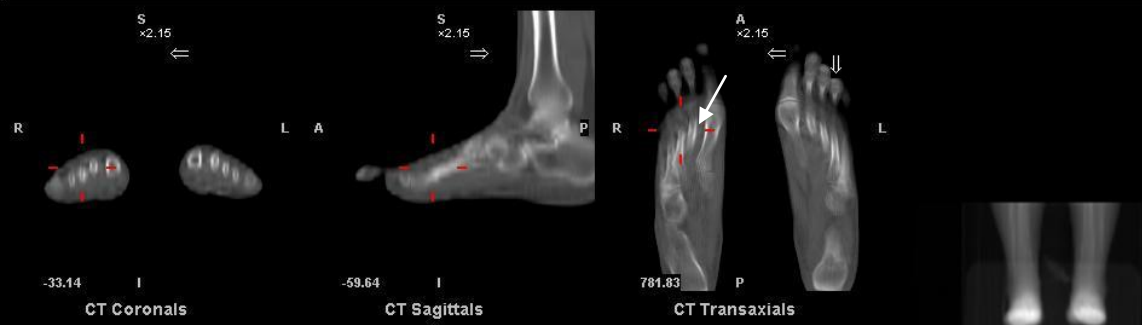
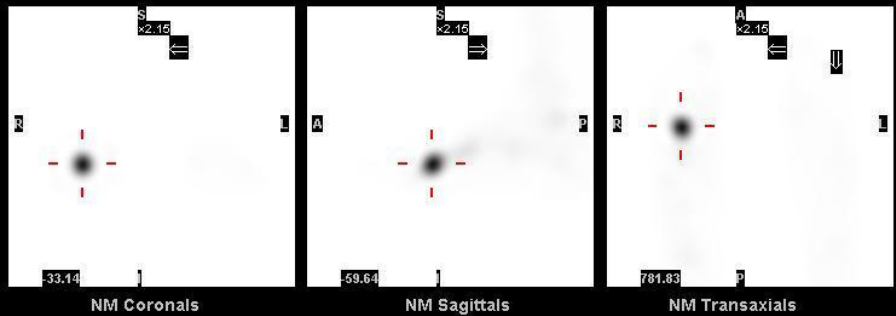
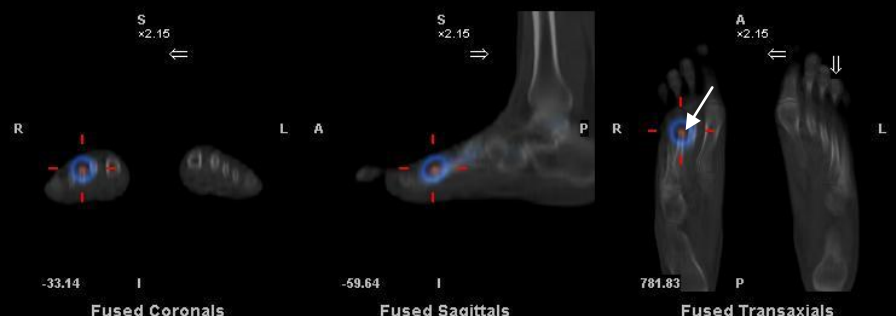
A SPECT / low dose CT scan of the feet was performed. The intense focus of abnormal uptake involving the right 3rd metatarsal, was localised to the neck. There was early callous formation (arrows). This was best seen on the transaxial slice.

Conclusion: There was a recent healing stress fracture of the neck of the right 3rd metatarsal with post-traumatic periostitis of the metatarsal shaft.
