STRESS FRACTURE OF THE PUBIC RAMUS.

BURWOOD NUCLEAR MEDICINE

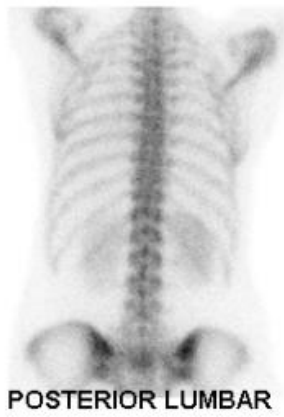
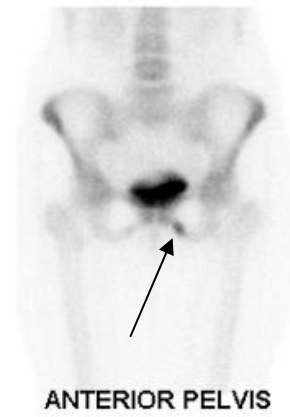
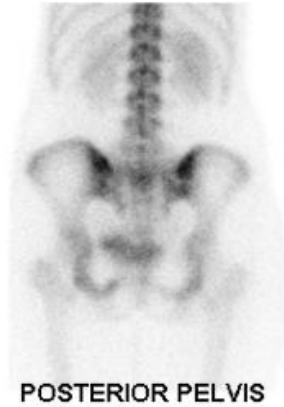
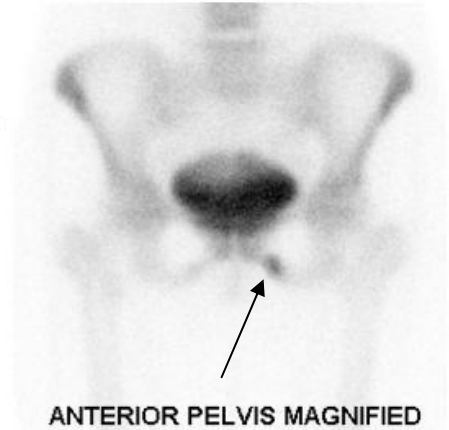
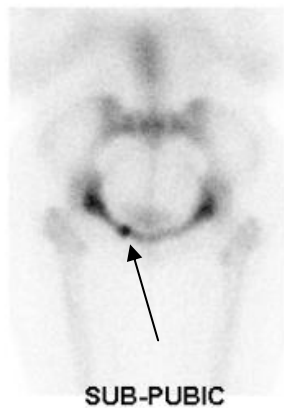
BONE

In the delayed images, there was a focus of moderate abnormal tracer uptake involving the left inferior pubic ramus. There was no abnormal uptake by the left femoral neck.

The scan appearance was typical of a recent healing (only mildly hyperaemic) stress fracture of the left inferior pubic ramus. The X-rays were reported normal, although on review a faint fracture line in the inferior pubic ramus was seen by the physician, which was consistent with the bone scan findings.
